# Manhole Inspection Summary

Manhole # S21C\_\_026MH

Insp Date: **10/16/07 1:17 PM**

**Location** Address: **522 KIRBY-FULTON**

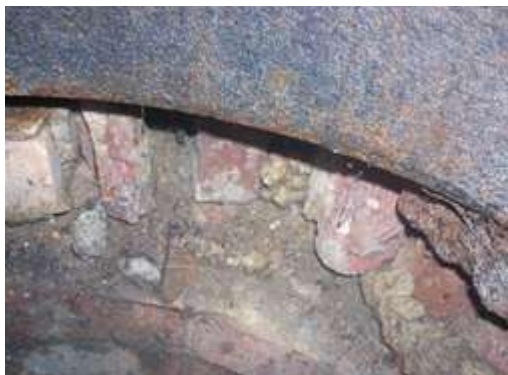
Defect 2

Condition: ☐ Sound ☐ Cracked ☐ Root Intrusion ☐ Loose Brick ☒ **Deteriorated**

DETERIORATED CHIMNEY

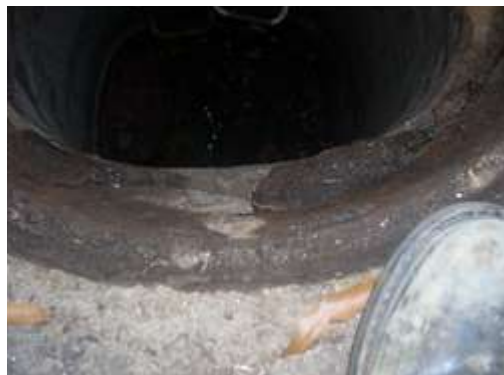
Defect 1

**Frame** Offset: **2** (in.) Condition: ☒ Sound ☐ Cracked ☐ Leaks

FRAME OFFSET

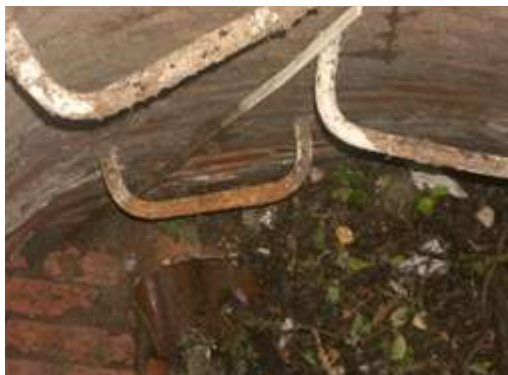
Defect 4

**Steps** Count: **5** Missing: **0** ☒ **Corroded**

CORRODED STEP

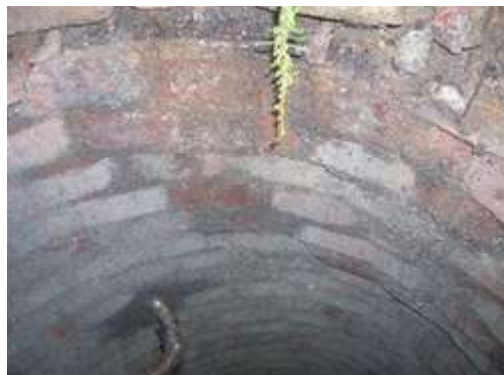
Defect 3

Condition: ☐ Sound ☒ **Cracked** ☐ Root Intrusion ☐ Loose Brick ☐ Deteriorated

Infiltration: ☐ None ☐ Joint ☐ Cracks ☐ Mortar ☐ Roots ☒ **Wall**

cracked and INFILTRATION OF THE CORBEL WALL

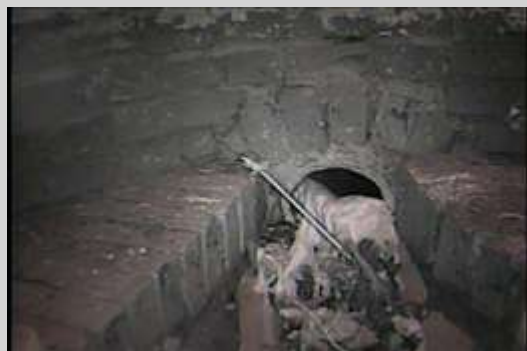
9 O'Clock Inflow

Deposits: ☐ None ☐ Mud ☐ Sludge ☒ **Debris** ☐ Grease

Silt Depth: **6** (in.) Deposits Extent: **Heavy**
